**Calaveras Public Utility
District (CPUD)**

**Jeff Davis
Water Treatment Plant
Evaluation**

**Mead
& Hunt**

April 6, 2015

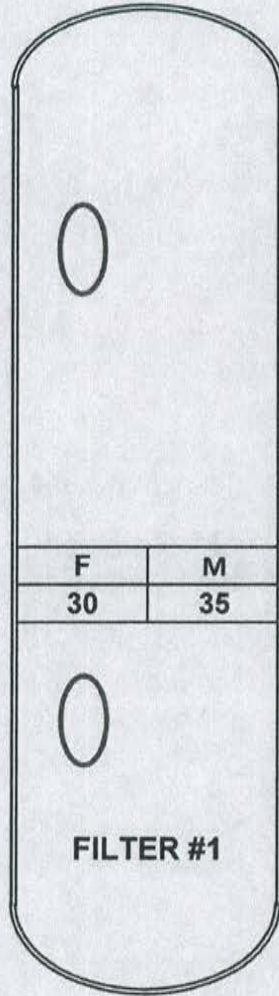
FILTER LAYOUT

Media Surface Condition Very thin layer of mud on surface. Very level surface with mounding along the walls.

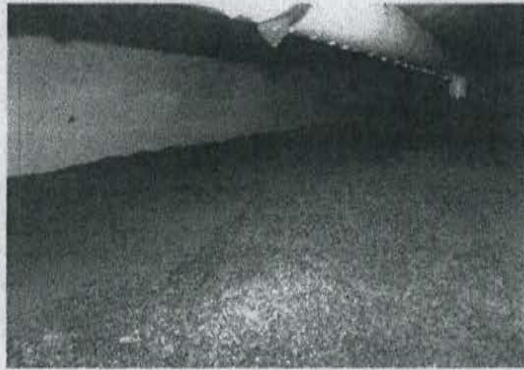
Staff added 3 1cf sacks of anthracite coal to filter 1

Staff added 30 pounds of 68% HTH calcium hypochlorite to filter 3 for a 24 hour shock. Treatment

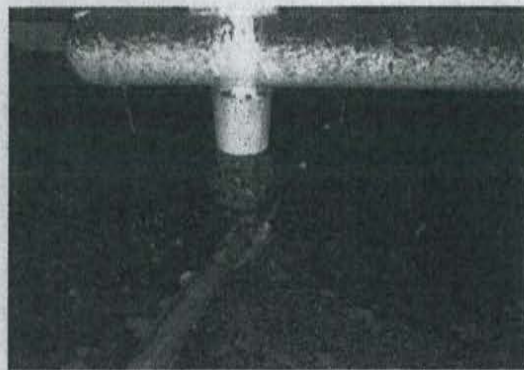
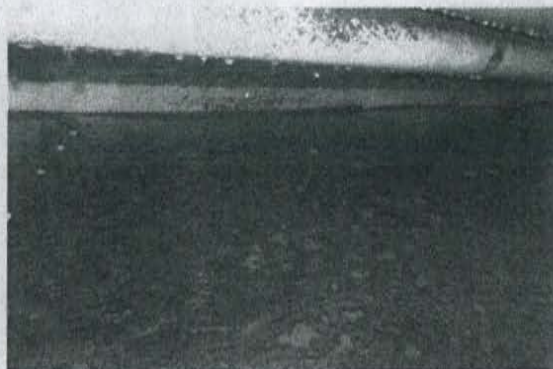
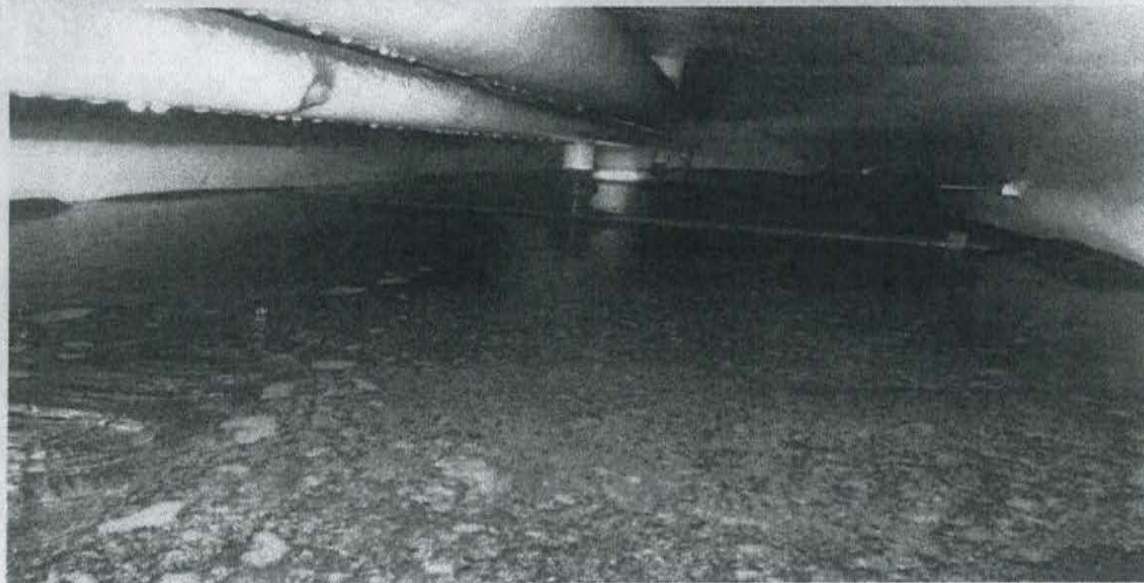
Refer to the zip lock one gallon sample bag marked filter 4

Comments: Surface wash cla-valve needs general maintenance.
 Filter media looks clean. Surfaces wash arms are working properly.
 Staff added 4 1cf sacks of anthracite coal to filter 3.
 Staff added 30 pounds of 68% HTH calcium hypochlorite to filter 4 for a 24 hour shock treatment
