**Calaveras Public Utility
District (CPUD)**

**Jeff Davis
Water Treatment Plant
Evaluation**

**Mead
& Hunt**

April 6, 2015

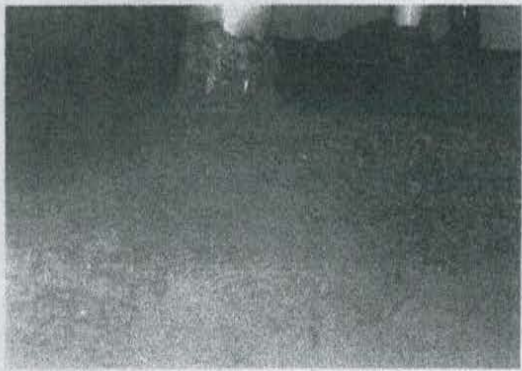
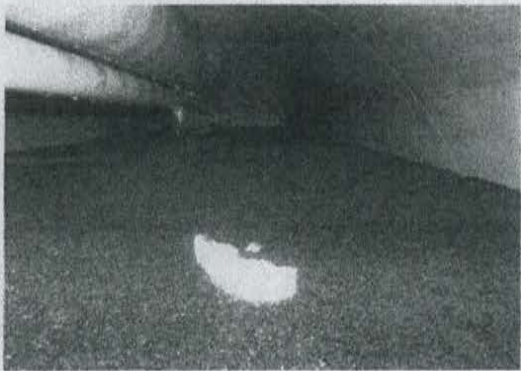
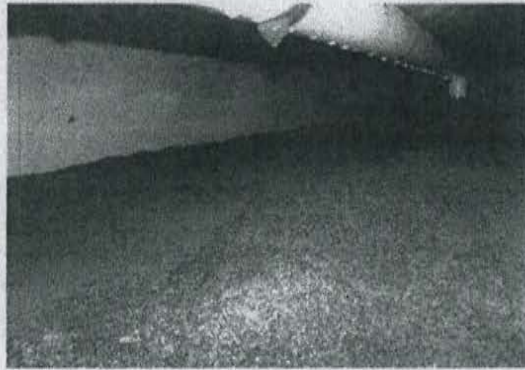
Surface wash inlet Cla-valve didn't open to inspect the surface wash spray arms until we
it along. The rotation arm did not spin after freed up with a shovels, there were some mud
4 to 16 inches down with in the media probably because of intermit surface washer fuctions.
most of the mud ball should deisolve from the HTH shock dosage, we may have to inspect this filter
again. After a few back washes to see if the surface washers are working properly.
Staff added 3 1cf sacks of anthracite coal to filter 1
Staff added 30 pounds of 68% HTH calcium hypochlorite to filter 3 for a 24 hour shock. Treatment

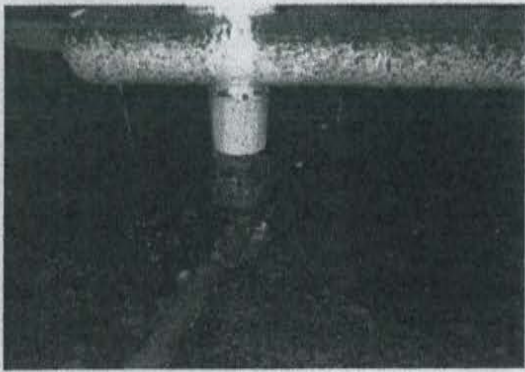
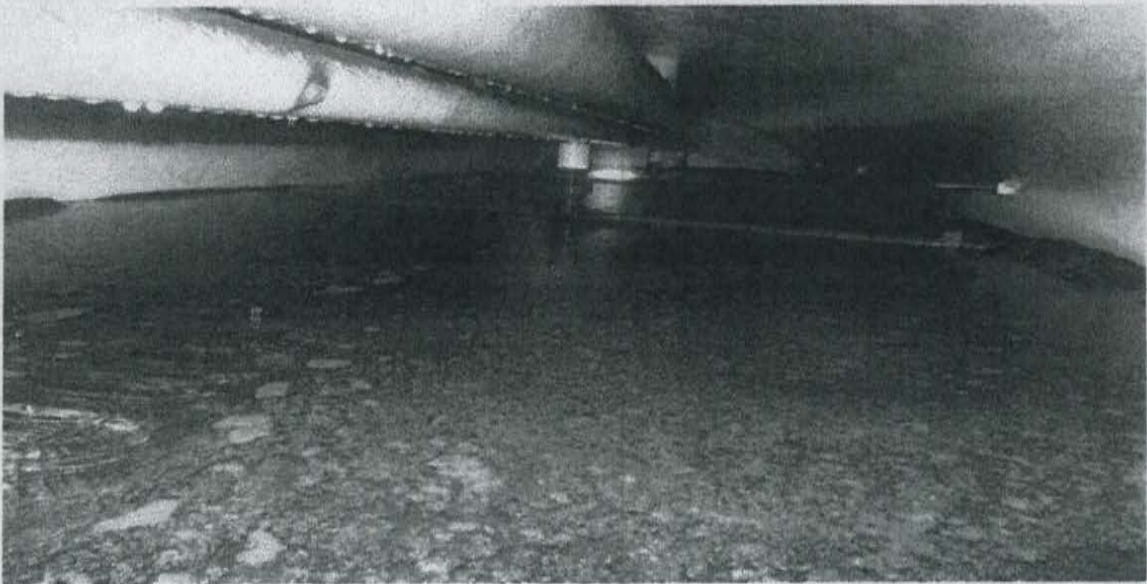
Refer to the zip lock one gallon sample bag marked filter 2

Comments: Filter media looked good,. Added 4 (1CF size) bags anthracite coal and 30 lbs. HTH 68% for 24 hr disinfection soak.

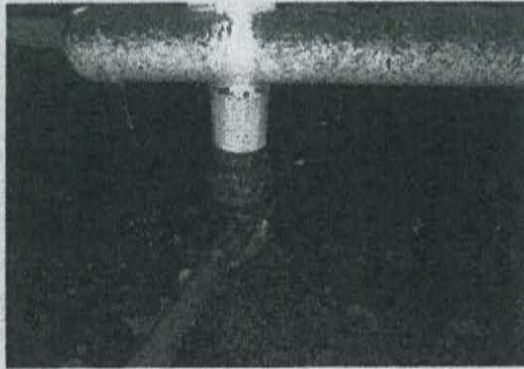
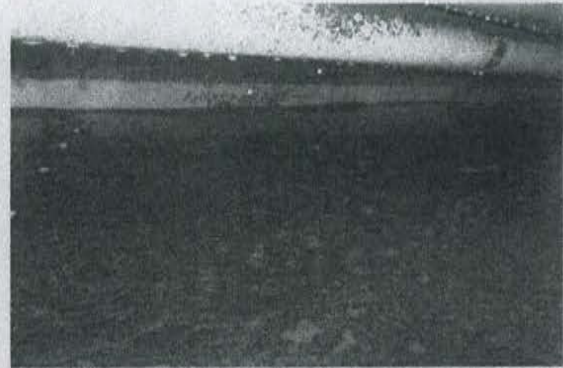
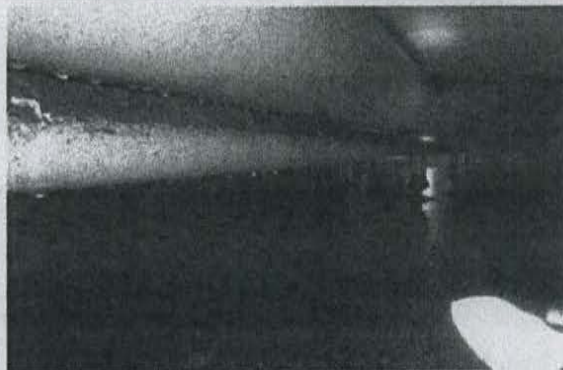
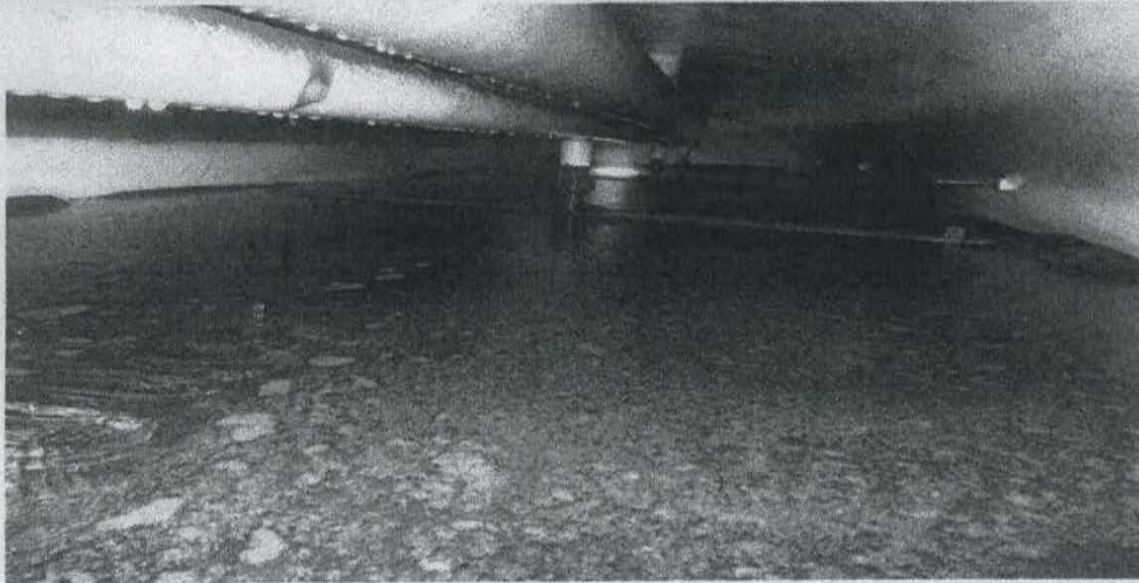
Staff added 5 1cf sacks of anthracite coal to filter 3.

Staff added 30 pounds of 68% HTH calcium hypochlorite to filter 3 for a 24 hour shock treatment

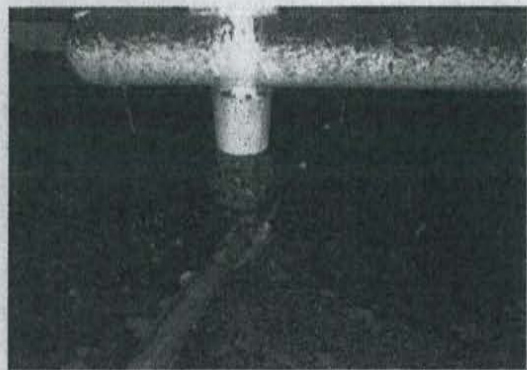
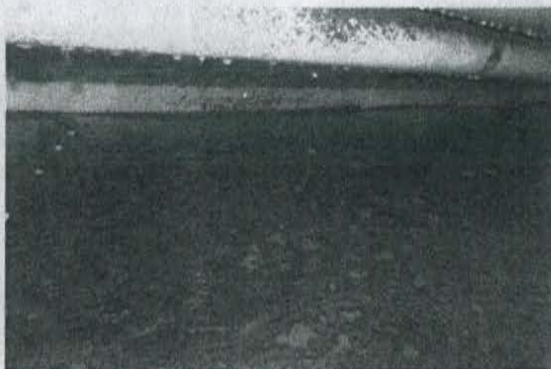
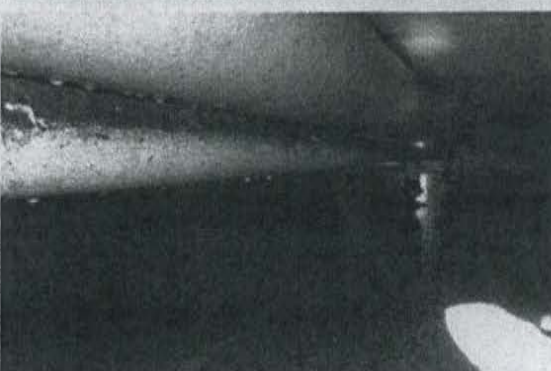
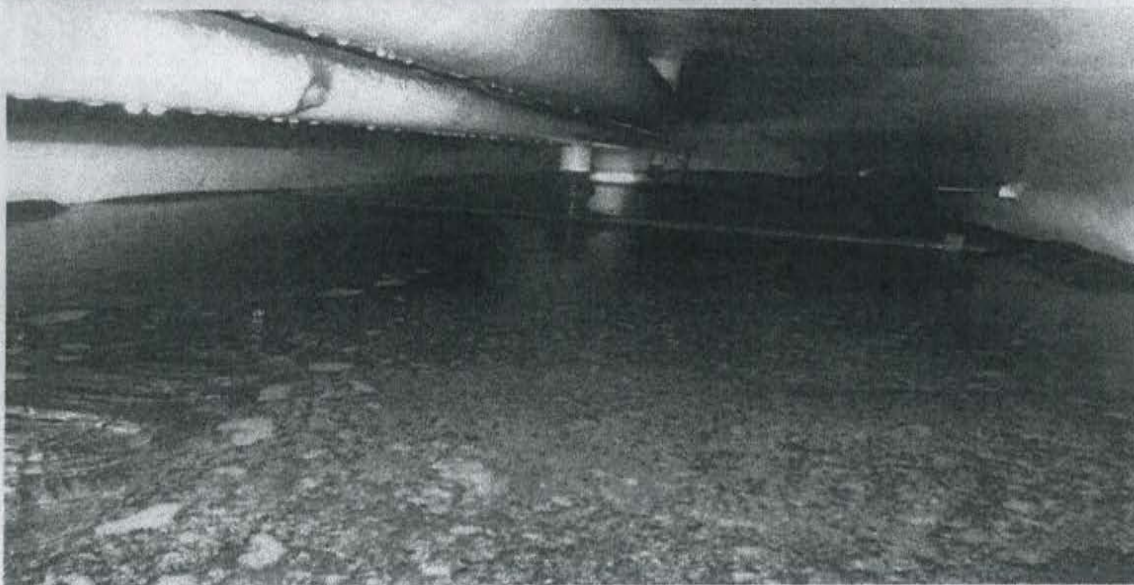
Staff added 4 1cf sacks of anthracite coal to filter 3.

Staff added 30 pounds of 68% HTH calcium hypochlorite to filter 4 for a 24 hour shock treatment
